Manhole Inspection Summary

Manhole # S17AA2011MH

Insp Date: **11/14/06 1:39 PM**

Location Address: **1701 ROGERS AVE**

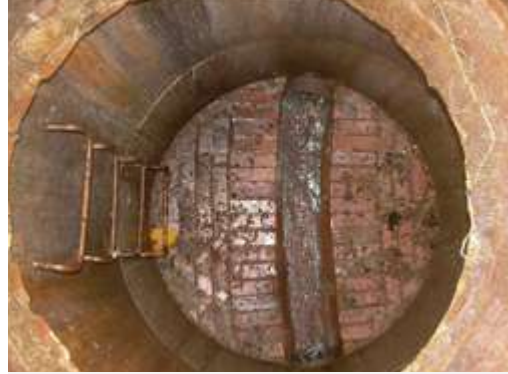
Top View

Corroded steps. Evidence of surcharge - Bench debris.

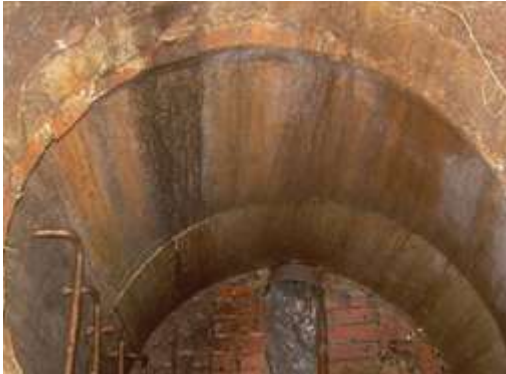
Defect

Frame leaks. Adjustment deterioration, root intrusion, and infiltration.

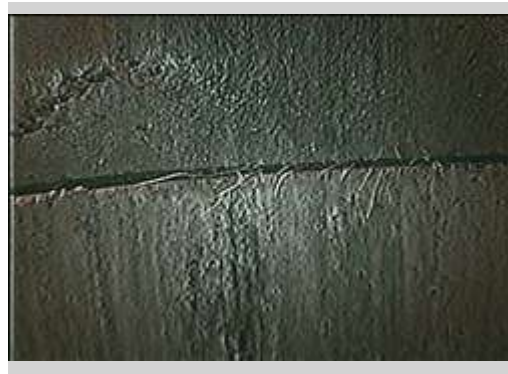
Defect

Barrel root intrusion.

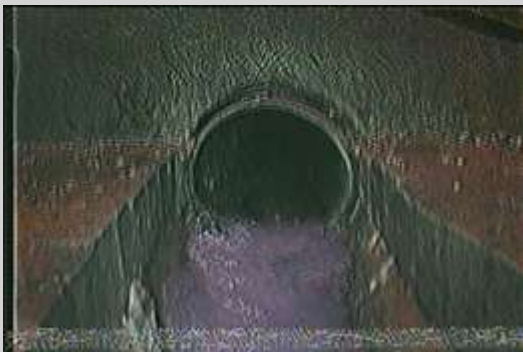
8 in. Circular Gravity Sewer Pipe Out @ 12 O'Clock

Comments **The O12 pipe seal is not flush to the pipe. The I6 pipe picture shows Channel deterioration.**

Infiltration: **Evidence** Pipe Seal Cond: **Unknown**

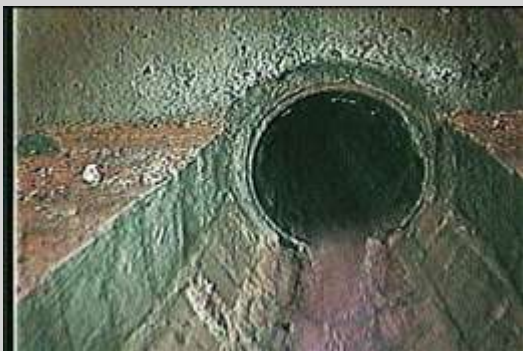
8 in. Circular Gravity Sewer Pipe In @ 6 O'Clock

Infiltration: **Evidence** Pipe Seal Cond: **Cracked**
